CASE HISTORY

ECP STEEL PIERS™ STANDARD MODEL 350

New Foundation & Structural Floor Stabilizes Residence Broomfield, Colorado

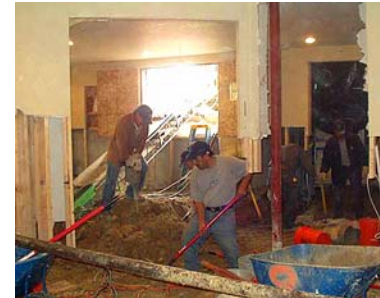
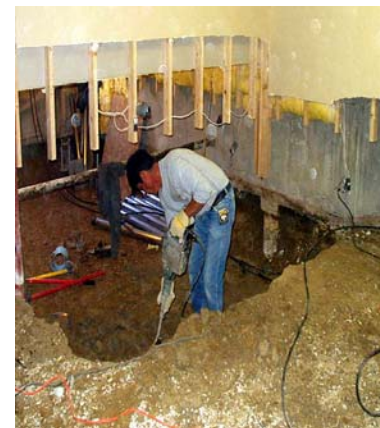
Photographs from top:

- Workers demolished the basement slab and remove up to 18" of soil to allow for disconnecting the existing concrete caissons and clearance for the new structural floor.
- The technician at right is using a rock drill to provide pier pipe access through shallow rock and boulders.

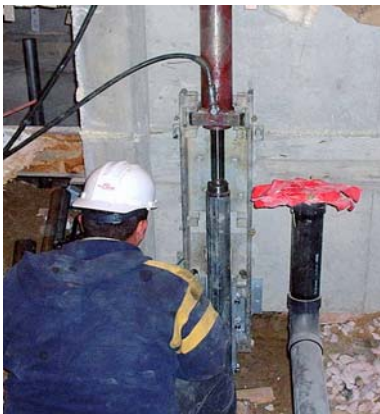
Photographs from top left:

- The pier installation configuration is shown. A drive stand was attached to the pier bracket. The pier pipe was then driven hydraulically to the bearing stratum. Notice that there are several 3-1/2 foot long sections of pier pipe visible next to the drive stand.
- A technician monitors the installation of the ECP Steel Pier™ pipe.
- Each ECP Steel Pier™ was load tested to twice the engineer's load requirement. Here a hydraulic ram applies the test load to the pier. The force on the system is monitored by the pressure gauge.
- Once all steel piers were installed and tested, the entire structural weight was transferred at the same time from the builder's caissons to the steel pier placements. This minimized the stress to the foundation beams and allowed for recovery of any lost elevation.

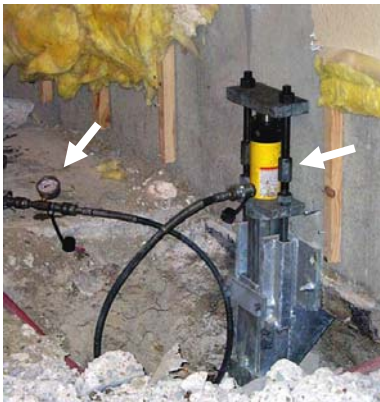
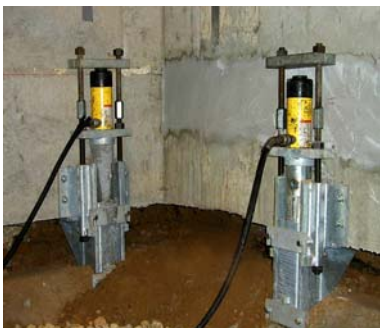
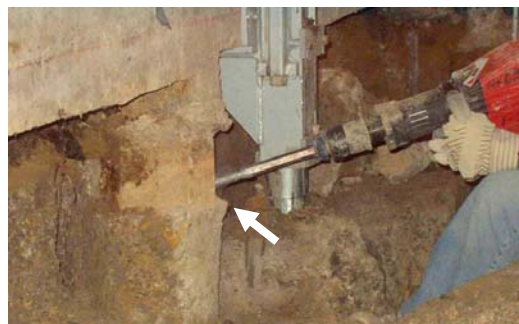
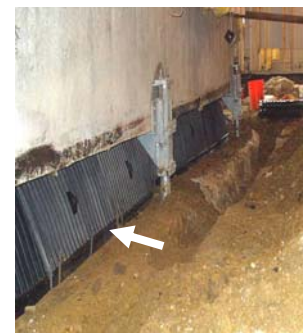
Photographs below:

- The original concrete caissons were cut from the foundation beam once the building weight was transferred to the ECP Steel Piers™, and then a soil retaining system was installed below the concrete beam prior to fabricating the new structural floor.

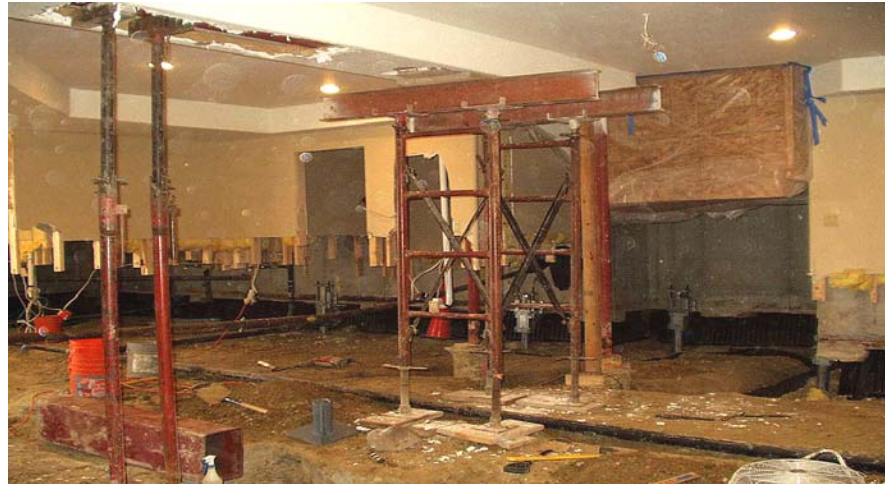
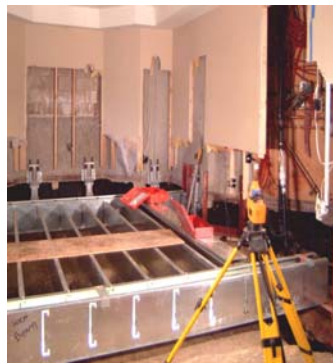
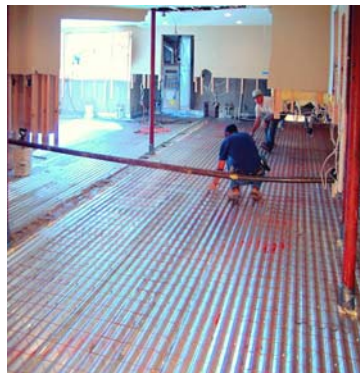
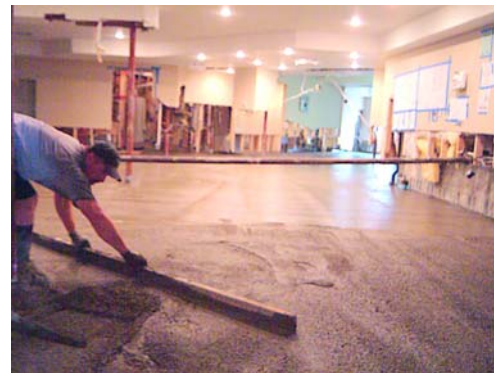
Photographs above:

- The view at the top right shows all piers installed with the loads transferred. The project is ready for the installation of the perimeter drainage piping and the structural floor system.
- In the photograph left above one can see the joist and girder framework being installed to support the new suspended concrete floor. The center photo shows the corrugated steel deck installation on top of the joist and girder framework. Finally, the new floor was cast. A radiant heating system was embedded to provide warmth in the basement.

With all of the ECP Steel Piers installed, tested and loaded; the project was ready for installation of the perimeter drain pipes and the new structural floor system. The new floor design was supported off the ECP Steel Piers™ and the existing concrete perimeter beams. The floor spanned above the soil under the house. This design provided support and stability to the entire structure on the 30 foot deep ECP Steel Piers™. The structure would no longer be subjected to the shrinking and swelling of the expansive soils found near the surface.

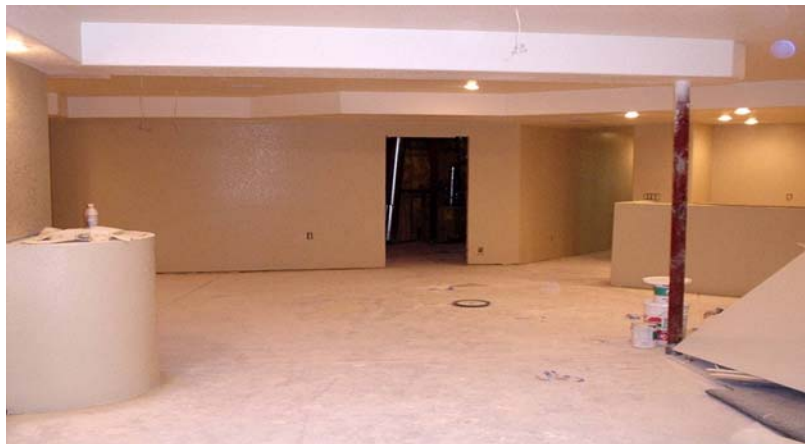
Photograph right:

- Once the floor system was completed, final cosmetic touches made the space ready for decorating.
